# THE NEW ZEALAND CLASSIC YACHT JOURNAL

# Ngatira is steadily coming back to life

## Ngatira restoration continued ...

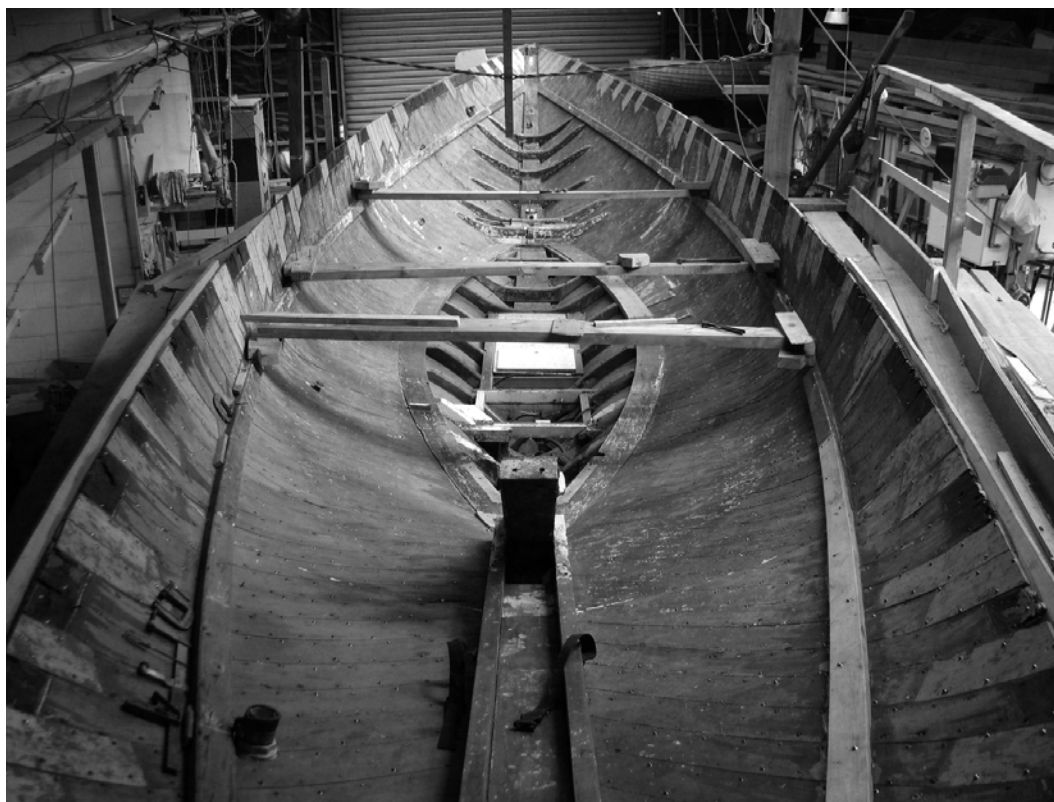
The 1964 fitted steel mast step had rusted severely and damaged three floors almost to the point of failure. The engine bed mounts had cracked two more floors. Jay removed an angle iron ring frame forward of the mast to reveal through hull fastenings that ran riot with the planking.

Steel nails that had rusted badly were found in several places in the interior fit-out and most recently we found a steel nail, square shank and headed, in the horn timber. I'm sure it is of 1904 vintage and was probably put in to hold the horn timber whilst the copper bolts were peined over. Nonetheless, it still caused damage.

steel fittings and fastenings installed in the 1964 refit have been the cause of most timber failure in *Ngatira*. Jay was going to scarf new timber in the horn timbers, but upon shaping out, the rot was found to run deep, the stern post the most alarming (see photo bottom left).

Repairs to damage received from the great storm of 1917, when *Ngatira* was left propped up against rocks off Devonport came to light. Plank head damage to the inner two layers is probably attributable to the 1964 fit-out as freshwater was allowed to enter and lie against the end grain.

Rotten plank ends have now been removed and new timber scarfed in. We decided to replace the sheer plank as the cove line had almost been sanded out. With the fitting of a rubbing rail and through bolts, the sheer plank was not in good shape either. It was far better to have new sheer plank and clamp to tie everything up.

After heading north to participate in the graduation of two departing students, I was happily relieved to see new sheer planks being fitted and all inner planking replacements scarfed in, also the replacement of about three metres of the starboard stringer.

has been pulled. The first few inches top and bottom look great, but we will make a decision about the rest of them once fully examined. Two-thirds of the clamp is fixed in and the other third is made, awaiting nails. The outer stem post is finished and inner portion is being cut out.
