*With winter upon us it seems appropriate to dedicate this issue of Classic Journal to the boats high and dry and getting some real love. Eileen Patricia, Lucinda and My Girl are three very lucky boats, which to varying degrees are being brought back to a condition which may be better than new. As ever, a sense of competition has entered the picture: 'Mency' has challenged Nathan that the first boat to reach the Kawau Boating Club has to shout dinner. It may be close considering their near identical lengths and engines. Here is our 'Around the Yards' edition ...*

## Eileen Patricia's March of Folly

# The Lucinda Project nears completion

## Making Progress on My Girl

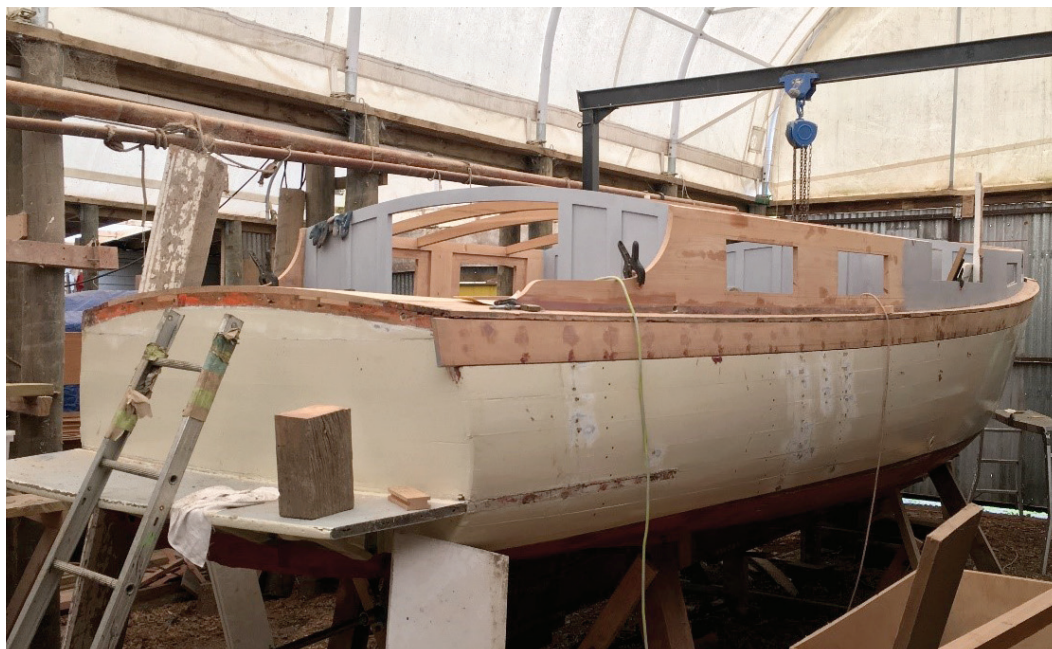
Peter Mence Photo

We have two original photographs, but no drawings.

One of the photographs was provided by Graeme and Brian Couldrey and is of enough quality to form the basis of our originality guide.

We were aware from charred timbers there had been a small fire in the bilge at some stage, but damage appeared to be superficial. We had anticipated re-using the coachroof beams. However, roof removal revealed charring on the top of the wheelhouse frame suggesting the fire was significant enough to cause the replacement of the whole cabin-top. We think that this was when the cabin was raised.

- 'Caravan cabin' off
- 'Tugboat' belting removed
- Sheer plank replaced starboard and mostly on port
- Fibre-glassed ply deck overlay off.
- Repaired log.
- A number of new ribs and repairs.
- The old 55hp Fordson came out – *still needs a new home.*
- New engine beds and a new Yanmar has gone in – *we will need to add ballast!*
- Kauri foredeck replaced.
- New stem piece scarfed in.
- Curved after deck

- New beams – *at the original height of course.*
- New aft cabin coamings.
- Repaired forward cabin coamings.

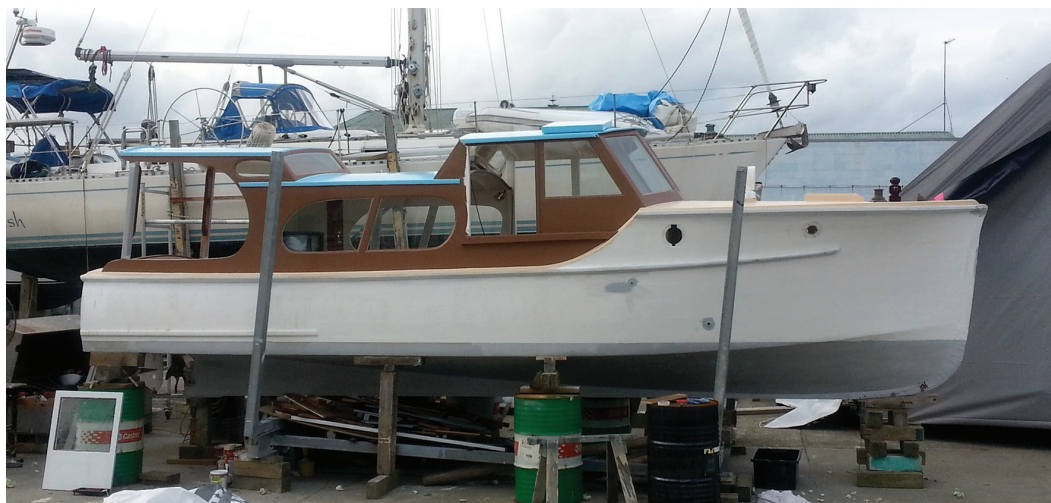
Nathan Herbert Photo

After more than two years, the *Lucinda* project is almost completed. Having been purchased as a 'mussel farm' in 2014 and after completely stripping her structure inside and out, she is now nearly fully renovated. Something that I have only learned at this late stage is that if your project is out in the open, for goodness sake plan the work to be done and make it appropriate for the season!

I had a rather successful summer fitting out *Lucinda* with her new wiring, plumbing and fuel systems, the quality of which makes me proud. But just about the end of April and into May, something I should have predicted happened: the dry, light weather ended and

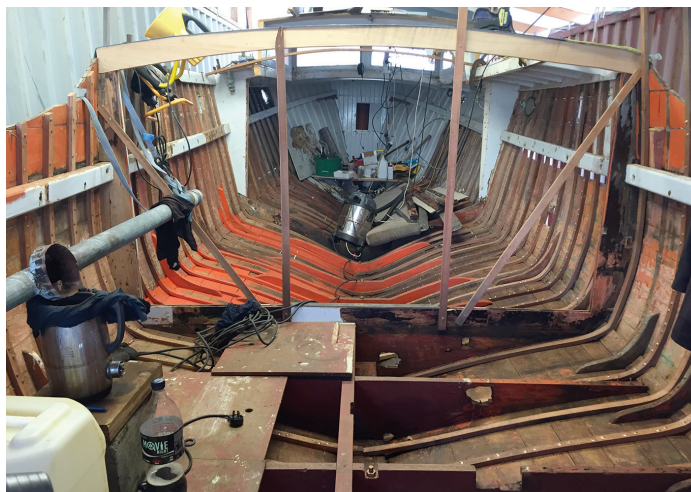
Jason Prew Photo

Frustrating day today. I decided to remove the sponson

on the starboard side. The bit from the transom to just past cockpit bulkhead went well. I'd wedge it out a bit, then cut the fastenings. But from there forward for 2m, it had been altered/repaid/botched with epoxy and glued firm to

Very solid, but during removal I lost the plank behind it. I just couldn't pry it off without destroying the plank.

back to normality, pry and cut. I cut the plank out in preparation for scarfing a new one in and have to do four more patches on this side anyway, so one more won't hurt.
